Analysis of the failure of a vacuum spin-pit drive turbine spindle shaft

**ANALYSIS OF THE FAILURE OF A VACUUM SPIN-PIT
DRIVE TURBINE SPINDLE SHAFT**

13. ABSTRACT (maximum 200 words) The Naval Postgraduate School's Rotor Spin Research Facility experienced a failure in the Spring of 2005 in which the rotor dropped from the drive turbine and caused extensive damage. A failure analysis of the drive turbine spindle shaft was conducted in order to determine the cause of failure: whether due to a material or design flaw. Also, a dynamic analysis was conducted in order to determine the natural modes present in the system and the associated frequencies that could have contributed to the failure of the shaft. It was concluded that the failure was due to low cycle fatigue, a possible stress concentration was identified, and a torsional mode was found near the speed at which failure occurred.

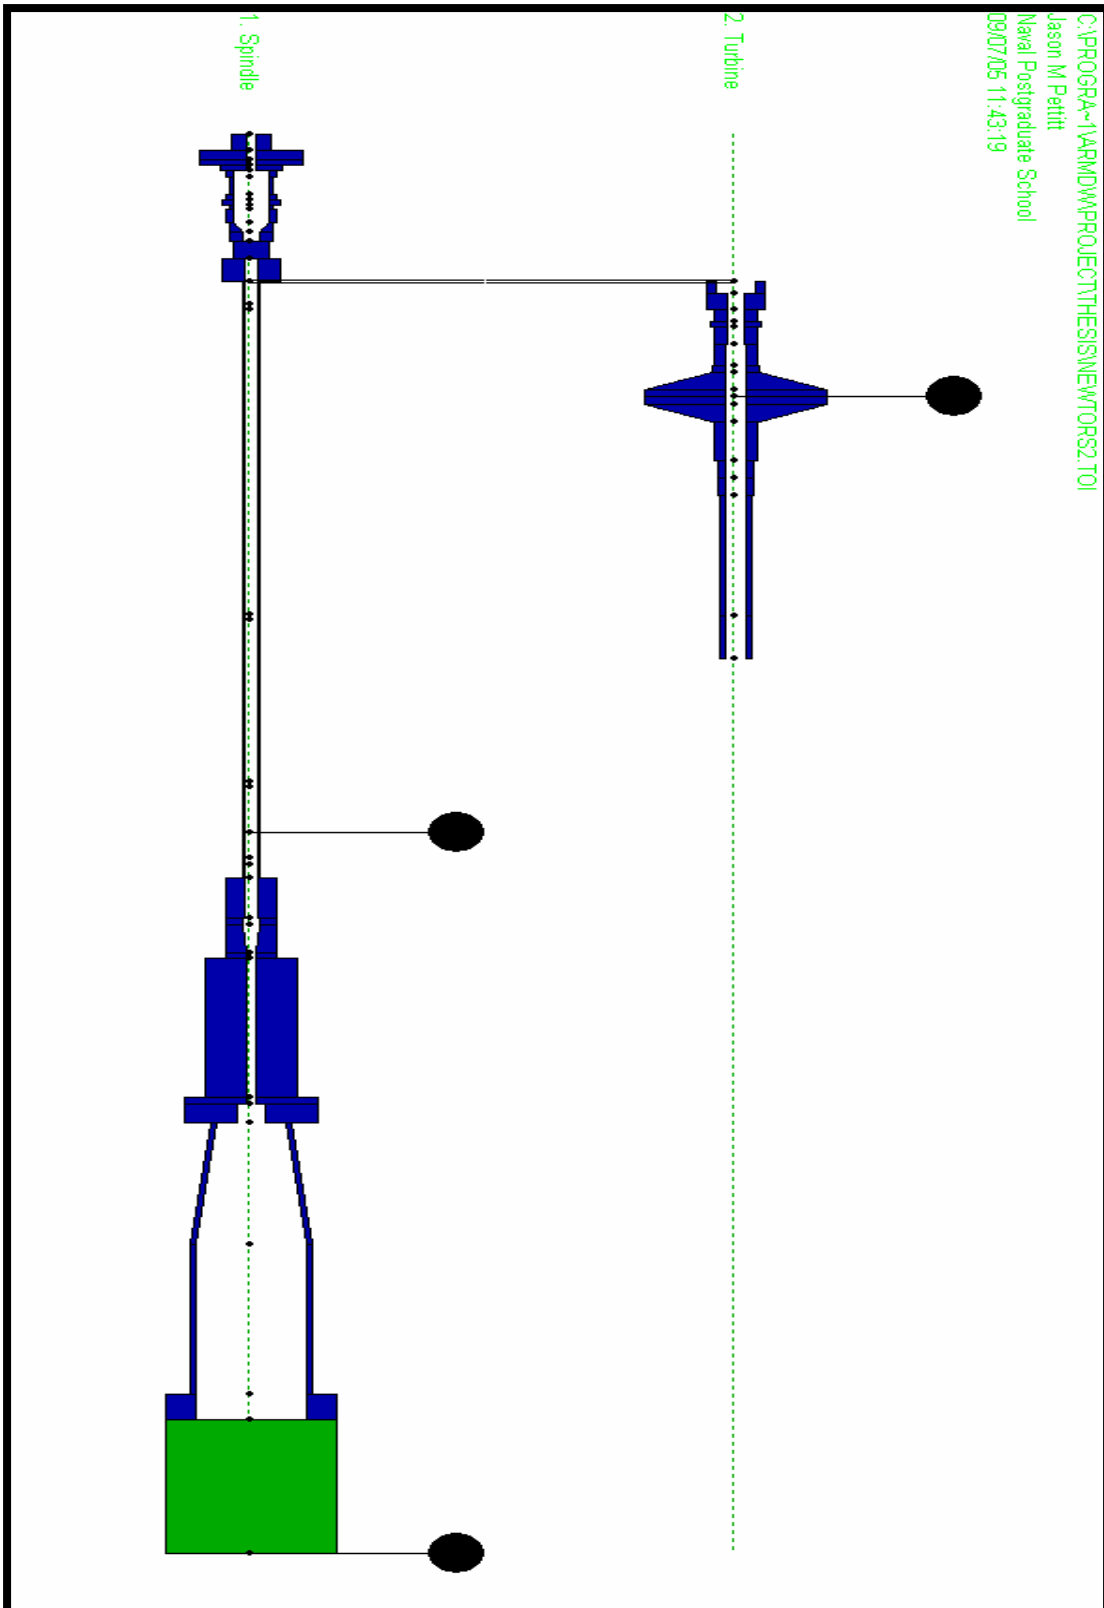
Figure 27. Torsional Vibration Model

Figure 27 shows the torsional model that was used in order to determine the natural torsional modes that were present. The torsional program in the ARMD software package allowed for the connection of the two branches from the rotor dynamics analysis. The models that were
